SUBJECT: East Penn Manufacturing Company, Inc. - Fatality Review

Employer Legal Name: East Penn Manufacturing Company, Inc.		Inspection Number: 1518156	6 Month Date: September 6, 2021
Date of Incident: March 6, 2021	Date of Death: March 6, 2021	Date of Report: March 7, 2021	Opening Conf. Date: March 7, 2021
CSHO Last Name: (b) (7)(C)	AAD Last Name: Zerbini	Type of Industry: Battery Manufacturing	Number of site ee: 125 Total number ee: 8000
Proposed Penalty: \$21,578.00	Incident Related Items: <input checked="" type="checkbox"/> Yes <input type="checkbox"/> No	NAICS Code: 335911	AAD Review: <input checked="" type="checkbox"/> Yes <input type="checkbox"/> No AD Review: <input checked="" type="checkbox"/> Yes <input type="checkbox"/> No
Multi-Employer Worksite: <input type="checkbox"/> Yes <input checked="" type="checkbox"/> No	Type of Employer: <input checked="" type="checkbox"/> Controlling <input checked="" type="checkbox"/> Correcting <input checked="" type="checkbox"/> Creating <input checked="" type="checkbox"/> Exposing <input type="checkbox"/> Not Applicable

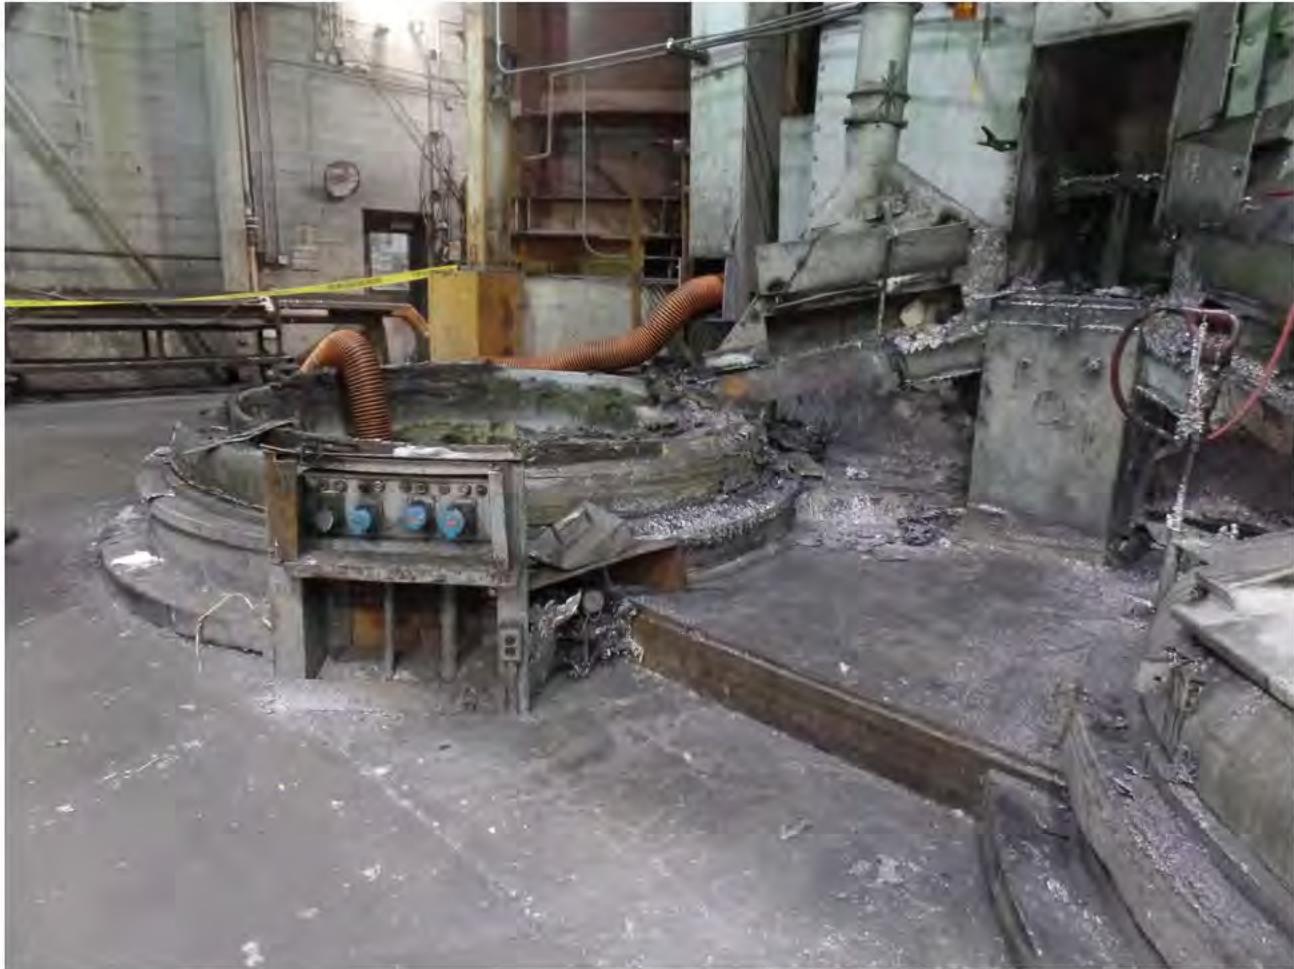
The investigation revealed that employees who work in the smelting department often worked in close proximity to the opening in the kettle lid while the kettles contained molten lead. The employer did not take the precautions necessary to prevent employees from exposure to falling into the kettle. As a result, there will be proposed citations under the walking working surface standard.

There were also additional hazards that were identified. When the kettle hoods are removed from the smelter kettles, employees are exposed to fall hazards into the kettles over the side of the tops of the kettles. There was also a reach to a step that was 24 inches from the floor. This step facilitates access to the work platform that is built into the tops of the kettle hoods.
